MINE SITE VISIT REPORT
New Mexico AML Program

Date of Visit : December 6, 2007 **Weather :** Cloudy 45°
Mine/Project Name: Blue Peak Mine – Northwest of Grants, New Mexico
Duration of Visit : 0.5 hour (1:15 pm to 1:45 pm)
Purpose of Visit : Maintenance inspection to the Blue Peak mine, part of the legacy site assessment for AML project sites.
Observations : Travel to the project site; access to this site was a difficult hike from the east.
Location T.13N., R.10W., Sec. 24, SE1/4,SW1/4,NE1/4 Dos Lomas Quad. UTM Zone 13, N3914420 E241600; Uranium Mine. This site is on BLM land.

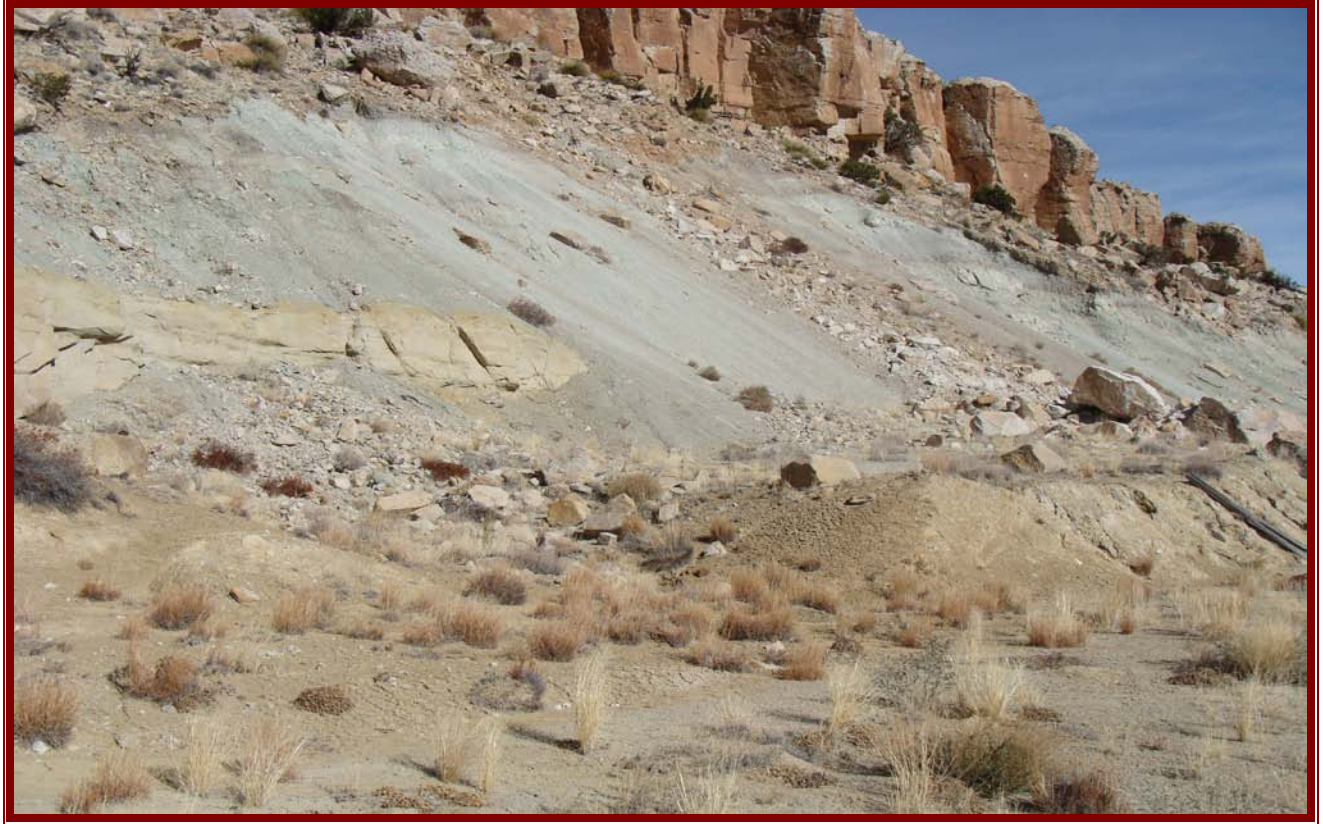
Signs of human activity were not recent. Site is difficult to get to. Vegetation is similar to undisturbed areas except waste piles that have less vegetation. Land use might allow limited grazing but none was noted. Previous reclamation is not obvious. Total site area is approximately 3 acres. The nearest residence appears to be about one half mile away in the south direction.

This site has areas of mounded waste, timber waste and assorted trash. There are two drainages running along through this site, one from the southwest and the other from the west. For complete details see topographic GPS info using the MapGuide map found at http://164.64.103.6/mmdtest/AML_Uranium-DEV.htm

Overall Site Looking East

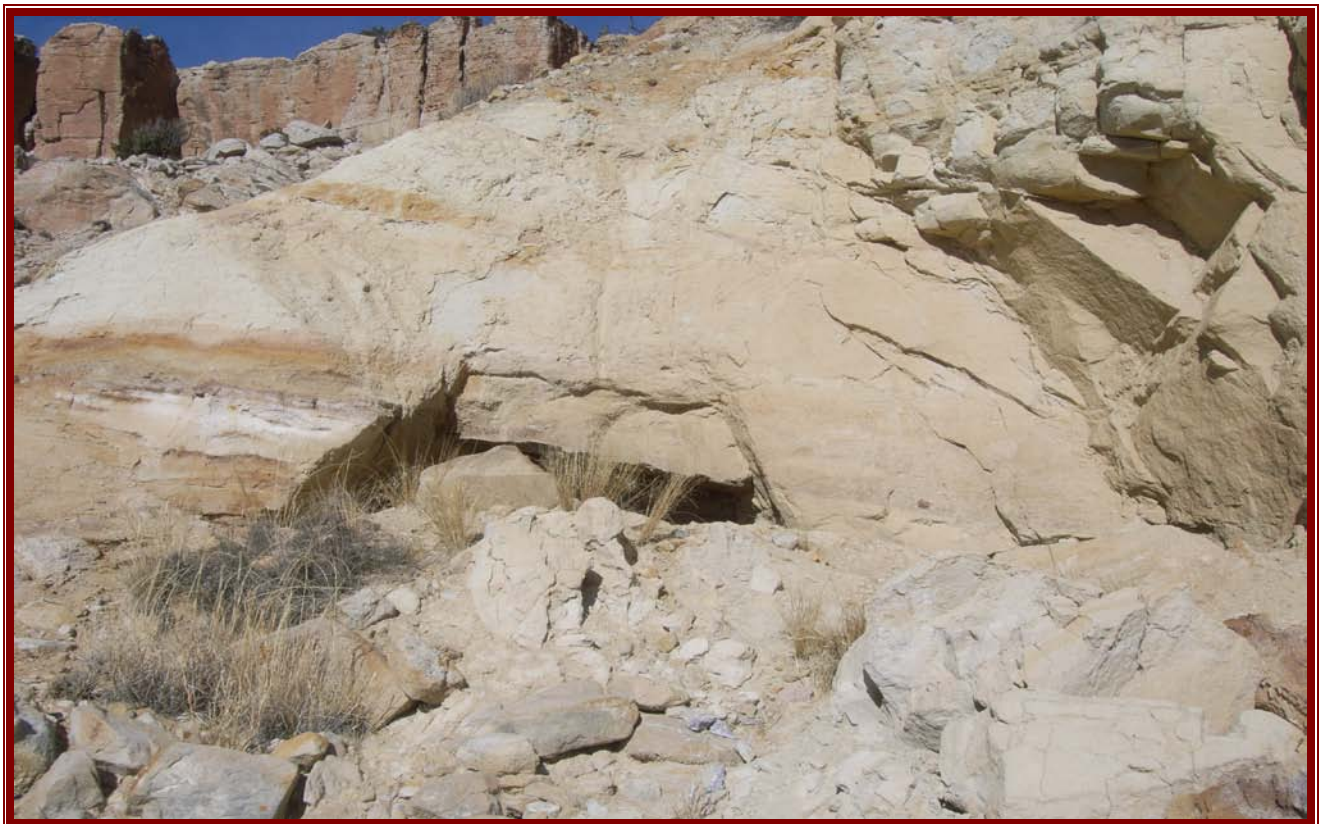
Opened Stope Looking North

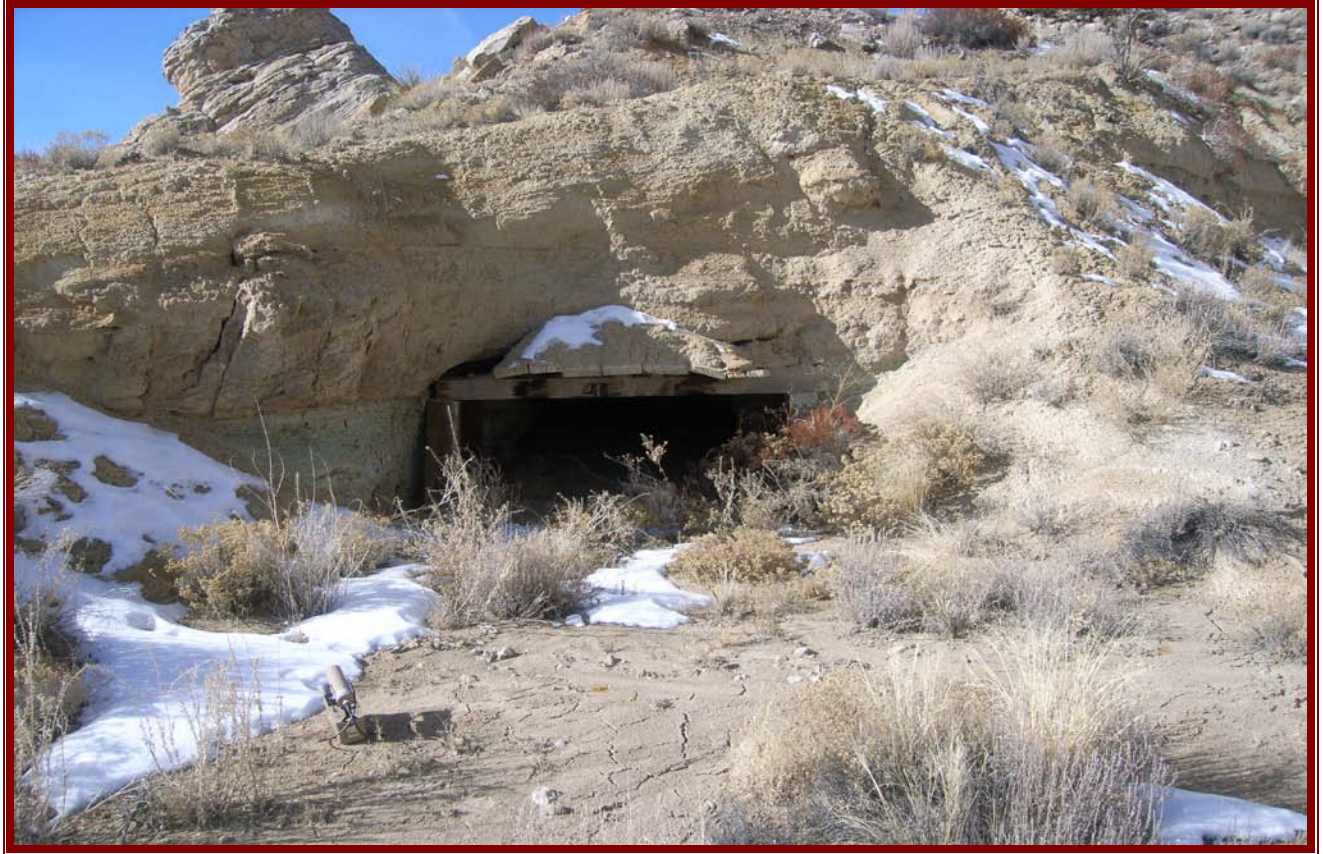
Background radiometric levels of 14 $\mu\text{R/hr}$ at 1-meter and surface, were read utilizing a Ludlum Model-14C survey meter with a NaI Model 44-2 Gamma Scintillator probe. The overall waste and ground within the middle portion of the disturbance area have radiometric levels of 234-286 $\mu\text{R/hr}$ at 1-meter and 371-486 $\mu\text{R/hr}$ at ground level. There was an open adit approximately 1/8 of a mile to the east that had radiometric levels of 166 $\mu\text{R/hr}$ at 1-meter and 286 $\mu\text{R/hr}$ at ground level near the opening.

Open Adit 1/8 Mile to the East Looking West

Further action recommended to close the open adit. Mitigation of radiometric levels would be impossible since the hillside is radioactive sandstone. Work might be done to reduce erosion and place signage labeling the area as radioactive.

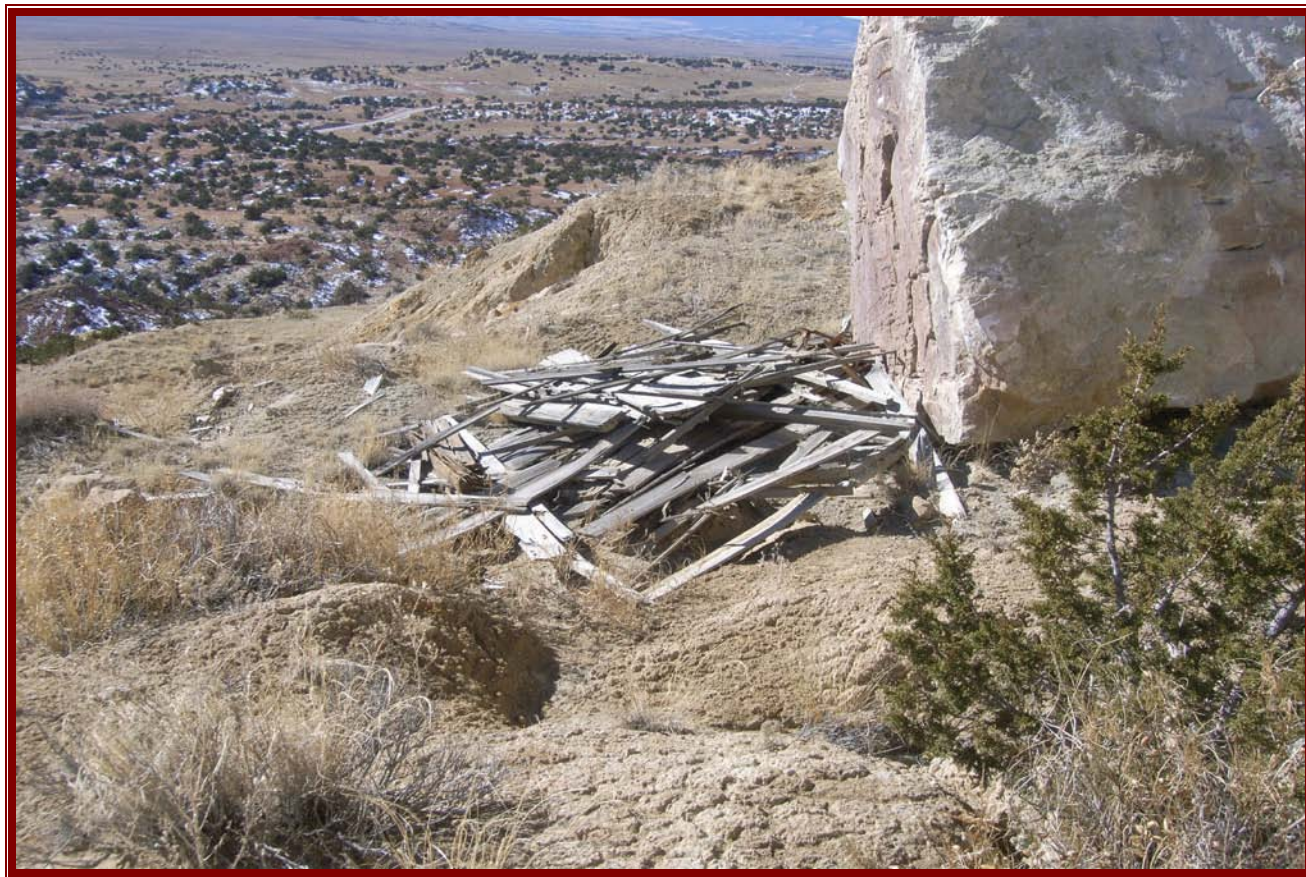
Collapsed Structure Looking West
